NATIONAL ADVISORY COMMITTEE FOR AERONAUTICS

December 1945 as
Memorandum Report E5K29

PROCESS OF LEAD-DEPOSIT ACCUMULATIONS ON

AIRCRAFT-ENGINE SPARK PLUGS

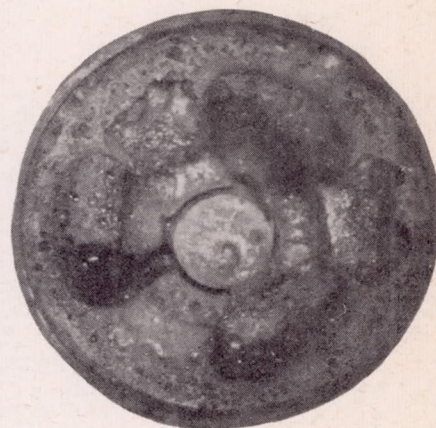
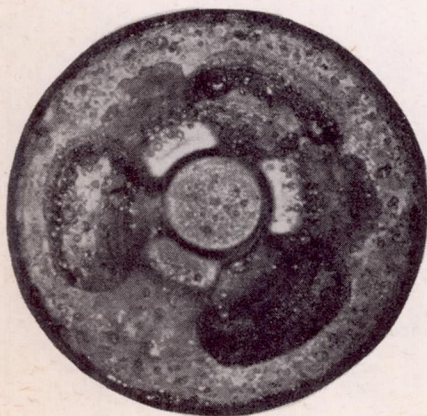
1 hour

10 hours

3 hours

15 hours

6 hours

18 hours

Figure 5. - Accumulation of deposit on a type B spark plug in exhaust position of V-1710 cylinder. Engine speed, 2000 rpm; manifold pressure, 30 inches mercury absolute; fuel-air ratio, 0.10; inlet-air temperature, 85° F; coolant temperature, 250° F; fuel, AN-F-28 with tetraethyl lead content increased to 18 milliliters per gallon (I-T mix).

Observations of deposits on many spark plugs at the Cleveland laboratory have shown that the appearances and characteristics of deposits formed under different conditions may be quite different. It is therefore impossible to designate any particular deposit typical; deposits similar to those of figure 5 have, however, been observed on badly fouled spark plugs from engines in service use.
